**Field Report for 2016 SPME Porewater Sampling and Surface Sediment Sampling
River Mile 10.9 Removal Action
Lower Passaic River Study Area**

December 8, 2016

This field report describes the solid-phase microextraction (SPME) porewater sampling and surface sediment sampling performed of the cap at the River Mile 10.9 (RM 10.9) Removal Area. The SPME samplers were deployed over three days in June 2016 and were recovered over three days in August 2016. During SPME sampler recovery, samples of surface sediments that had accumulated since cap construction were also collected. A representative of Region 2 (from CDM Smith) was present during all field activities. This field report also describes the visual cap inspection performed over two days in July 2016. This work was performed as described in the Lower Passaic River Study Area River Mile 10.9 Post-Construction Monitoring Quality Assurance Project Plan, Revision 2 (QAPP) submitted to US EPA Region 2 (Region 2) on April 12, 2016 and the draft River Mile 10.9 Removal Action Long-Term Monitoring and Maintenance Plan, Revision 2, submitted to Region 2 on April 12, 2016 (LTMMP). A subsequent revision to the QAPP (Revision 3) was submitt

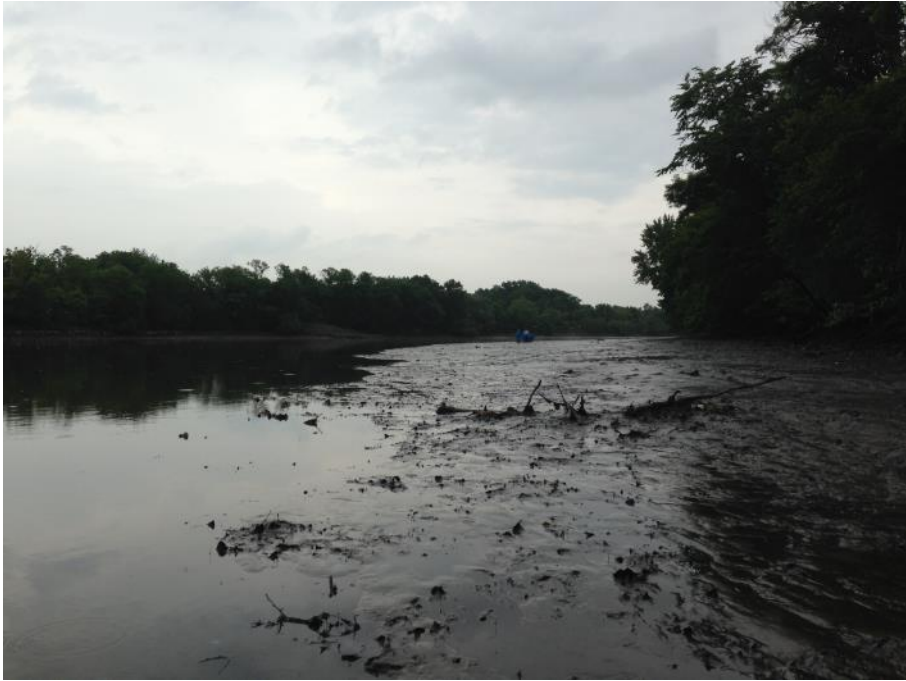
PHOTOGRAPHIC LOG		
Client Name: DMI		Site Location: Lower Passaic River (River Mile 10.9)
		Project No. 60270961
Photo No. 1	Date: 06052016

Direction Photo Taken: Northwest		
Description: Looking from 16A-0601 upriver (toward other stations) around Low tide.

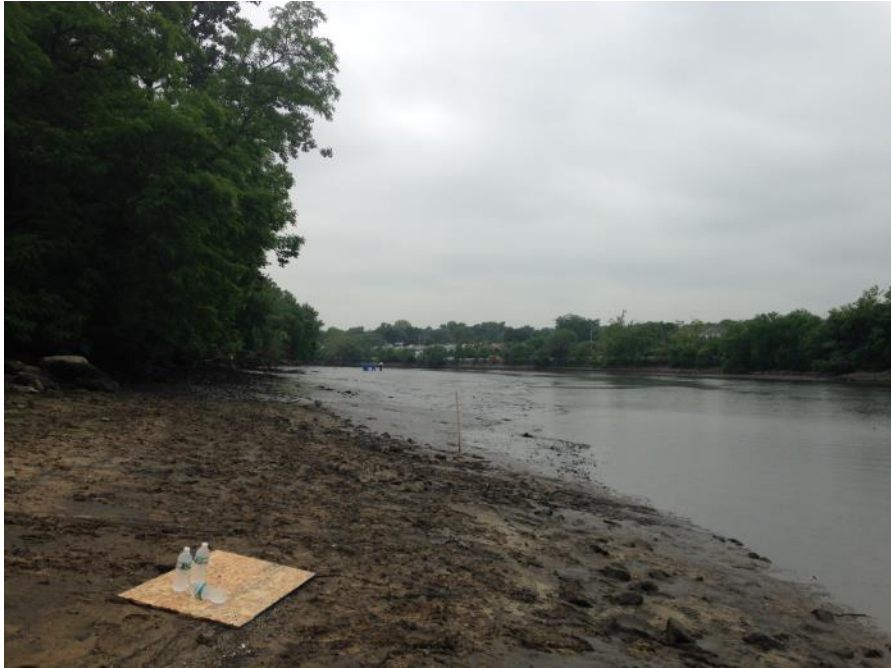
Photo No. 2	Date: 06032016

Direction Photo Taken: South		
Description: Looking downriver from above 16A-0608 around Low tide.

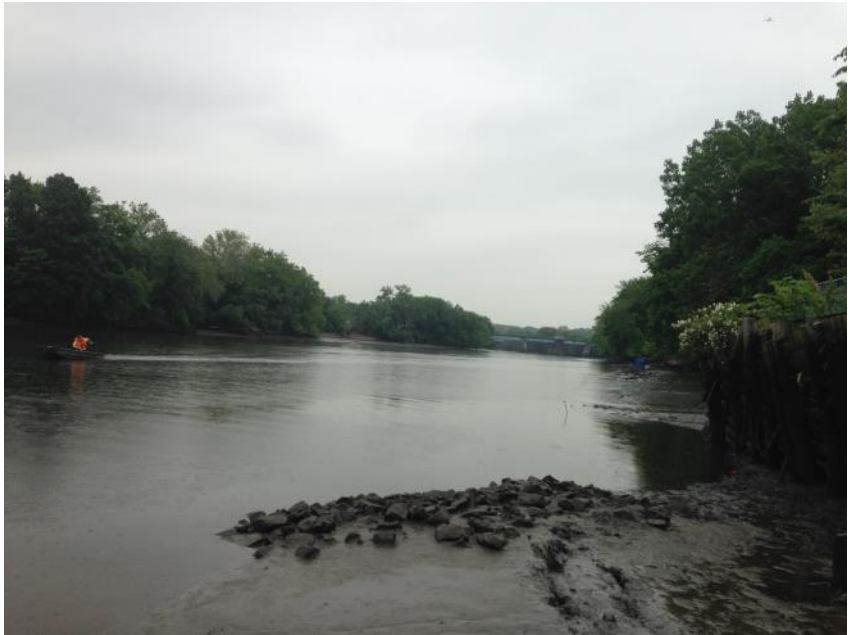
PHOTOGRAPHIC LOG		
Client Name: DMI		Site Location: Lower Passaic River (River Mile 10.9)
Project No. 60270961		
Photo No. 3	Date: 06032016

Direction Photo Taken: Northeast		
Description: Looking upriver from near 16A-0608

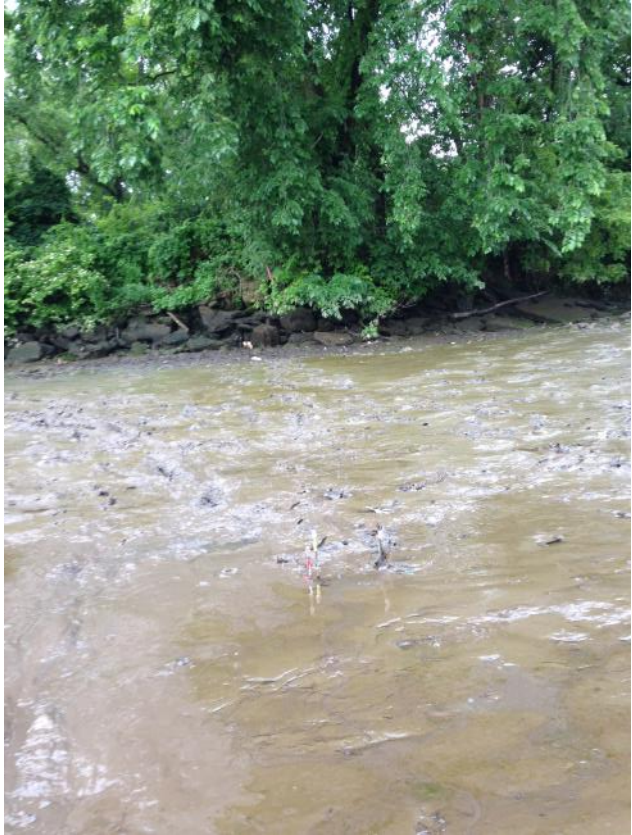
Photo No. 4	Date: 06042016

Direction Photo Taken: East		
Description: Installed 16A-0601

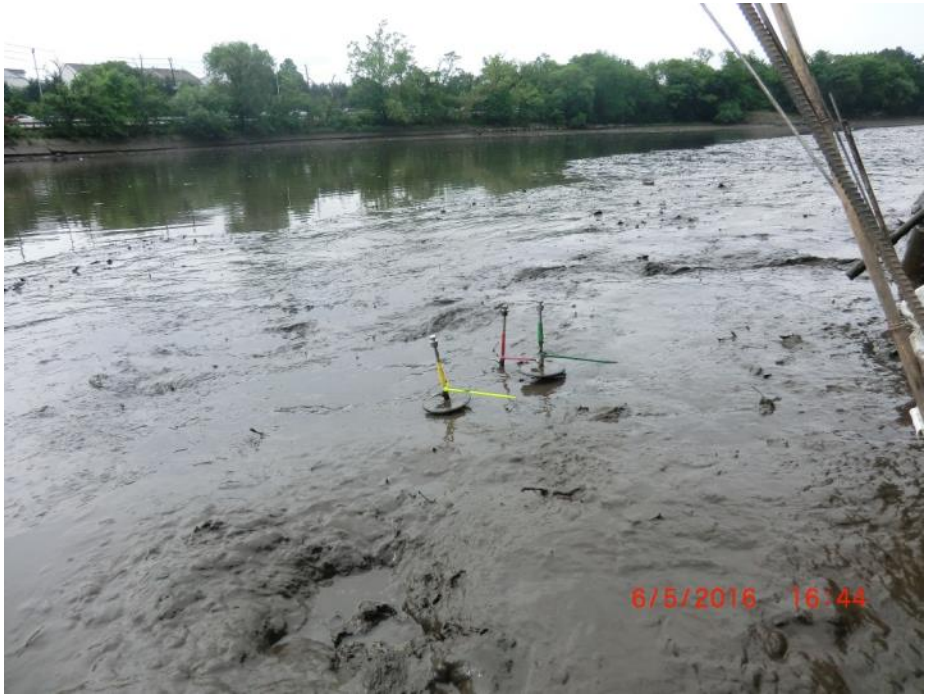
PHOTOGRAPHIC LOG		
Client Name: DMI		Site Location: Lower Passaic River (River Mile 10.9)
Project No. 60270961		
Photo No. 5	Date: 06052016

Direction Photo Taken: North		
Description: Installed 16A-0602

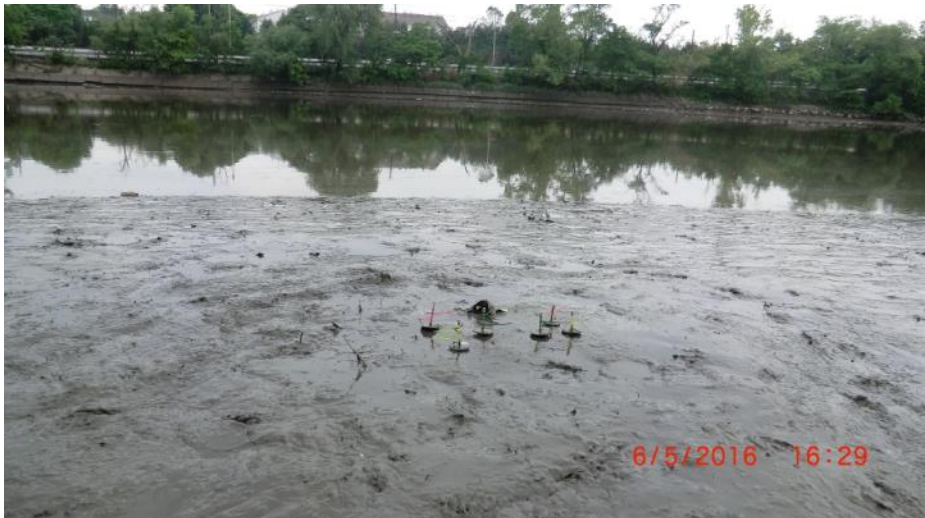
Photo No. 6	Date: 06052016

Direction Photo Taken: Northwest		
Description: Installed 16A-0603 & duplicates

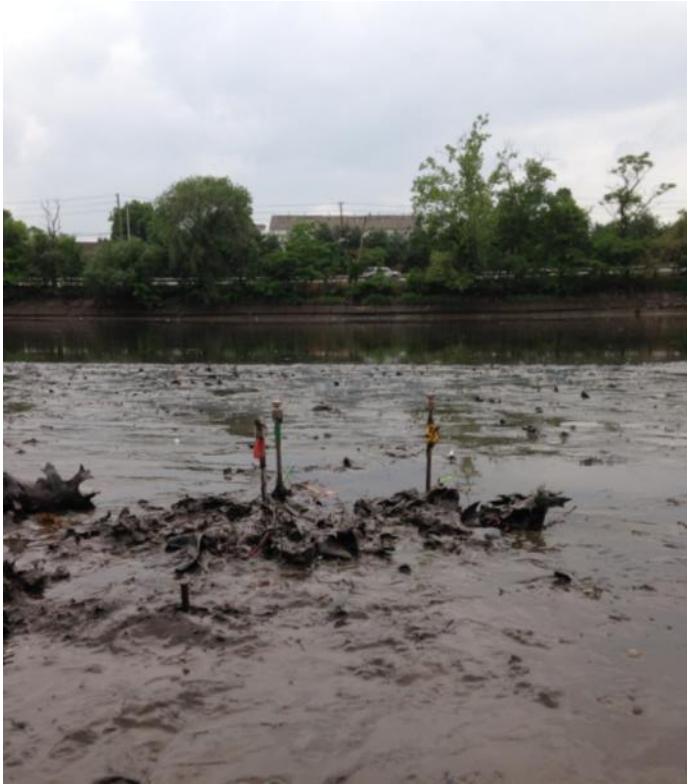
PHOTOGRAPHIC LOG		
Client Name: DMI		Site Location: Lower Passaic River (River Mile 10.9)
Project No. 60270961		
Photo No. 7	Date: 06042016

Direction Photo Taken: Northwest		
Description: Installed 16A-0604

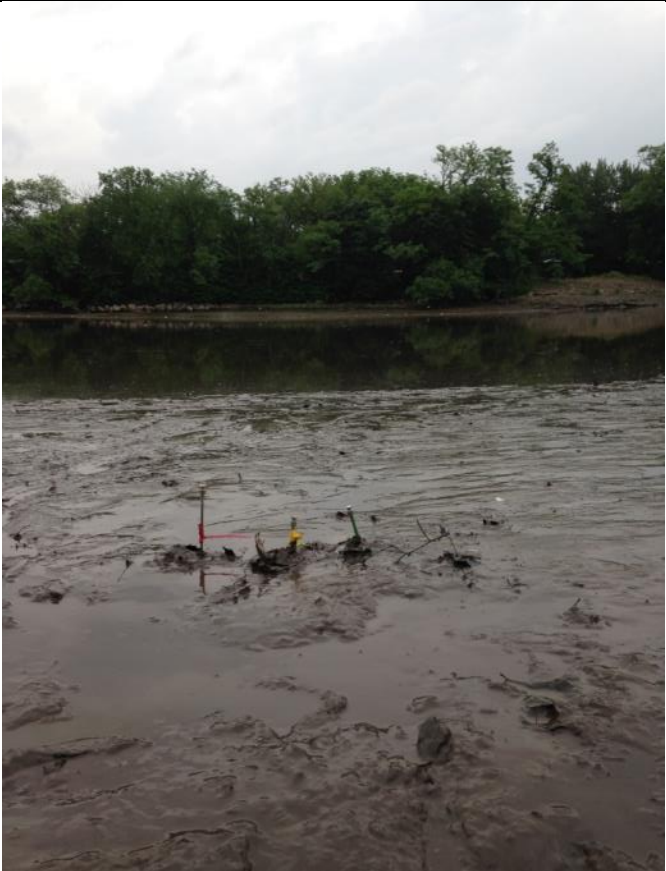
Photo No. 8	Date: 06042016

Direction Photo Taken: Northwest		
Description: Installed 16A-0605

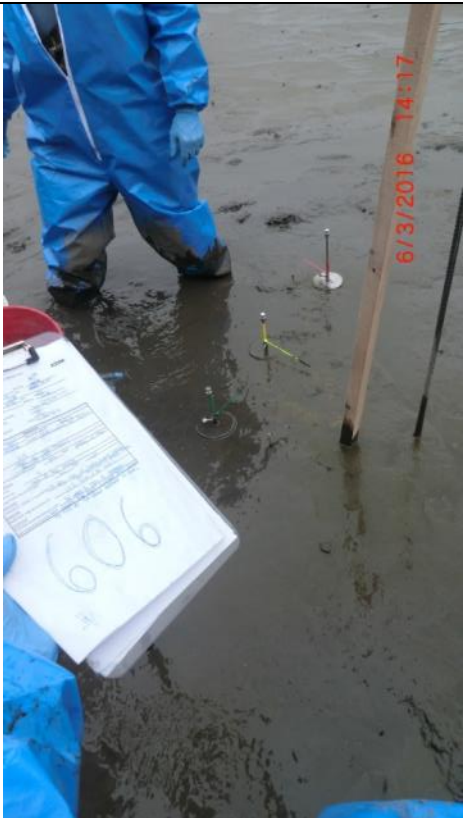
PHOTOGRAPHIC LOG		
Client Name: DMI		Site Location: Lower Passaic River (River Mile 10.9)
Project No. 60270961		
Photo No. 9	Date: 06032016

Direction Photo Taken: North		
Description: Installed station 16A-0606

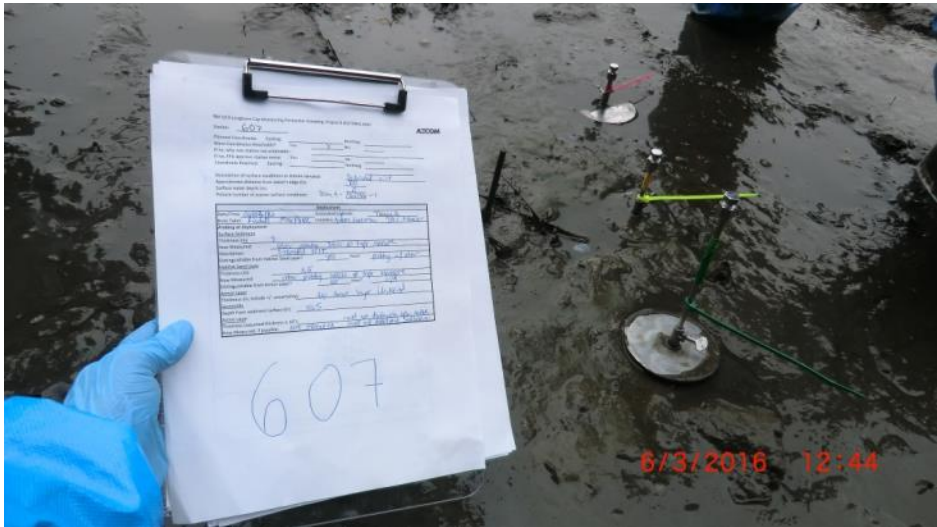
Photo No. 10	Date: 06032016

Direction Photo Taken: North		
Description: Installed station 16A-0607

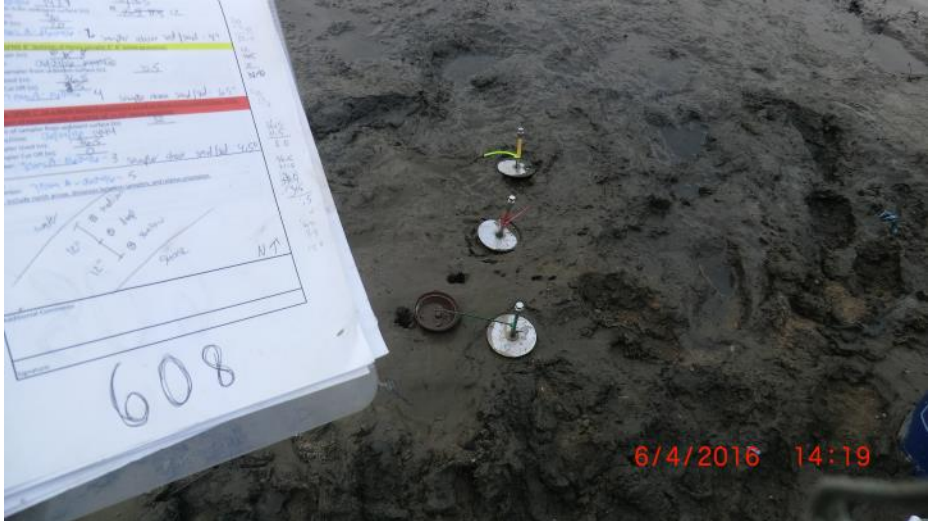
PHOTOGRAPHIC LOG		
Client Name: DMI		Site Location: Lower Passaic River (River Mile 10.9)
Project No. 60270961		
Photo No. 11	Date: 06042016	
Direction Photo Taken: North		
Description: Installed Station 16A-0608

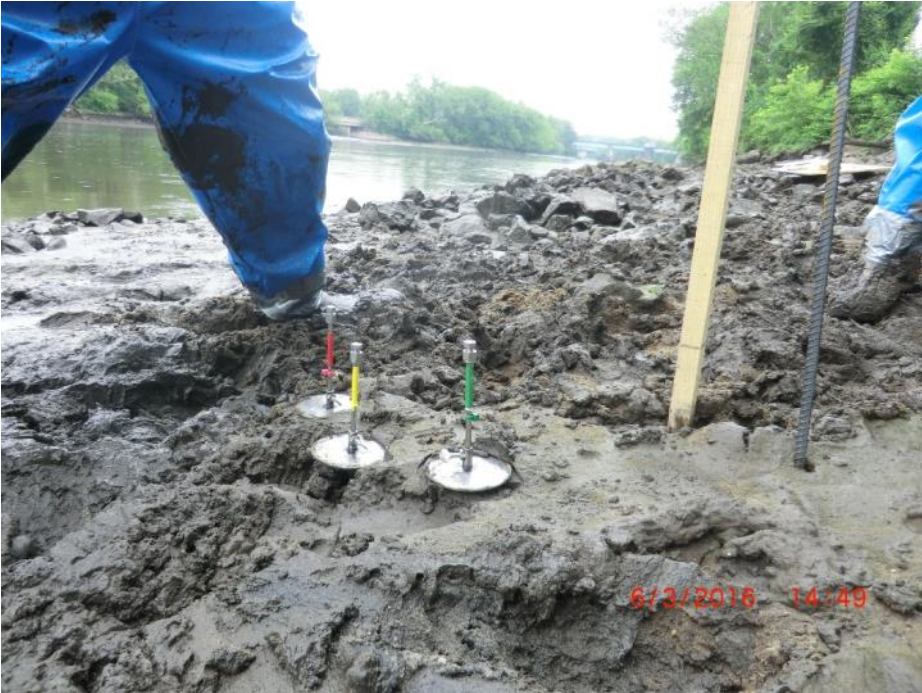
PHOTOGRAPHIC LOG		
Client Name: DMI		Site Location: Lower Passaic River (River Mile 10.9)
Project No. 60270961		
Photo No. 13	Date: 06032016

Direction Photo Taken: Northeast		
Description: Installed Station16A-0610		
Photo No. 14	Date: 06032016

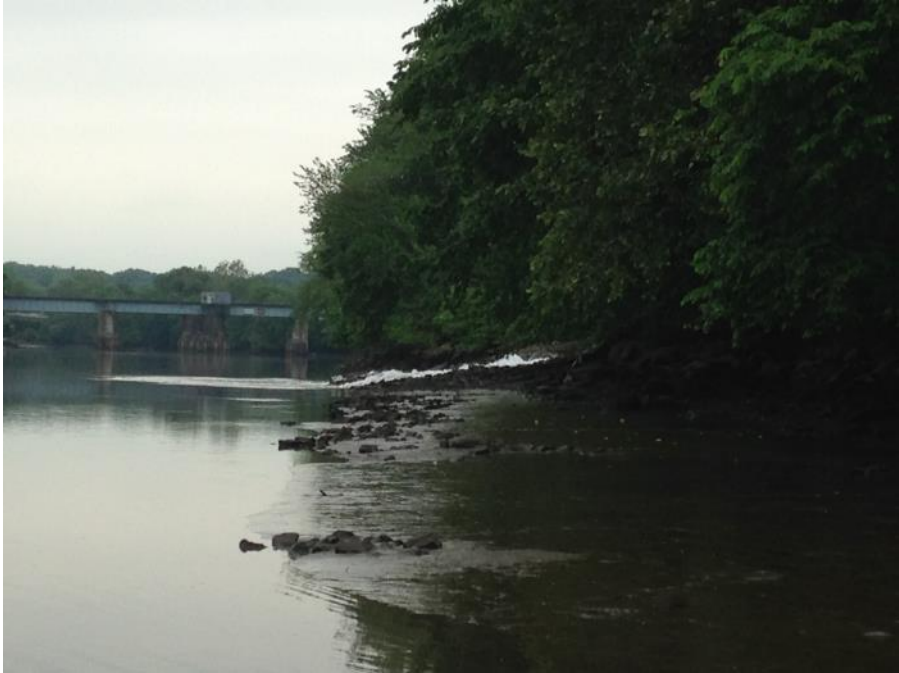
Direction Photo Taken: East		
Description: @ 12:42 PM observed stormwater discharge from culvert located on bank above 16A-0610.

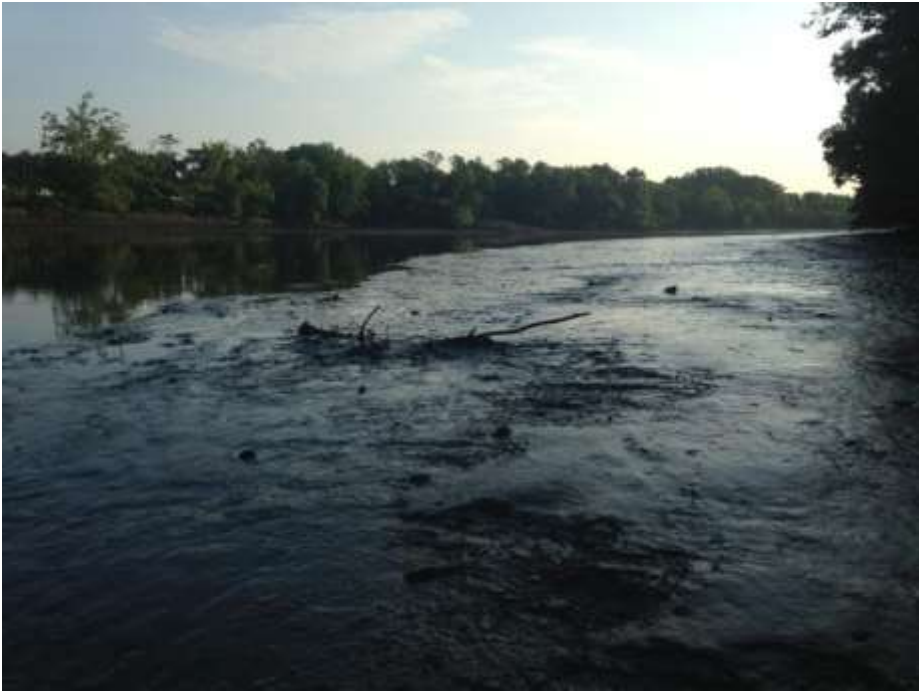
PHOTOGRAPHIC LOG		
Client Name: DMI		Site Location: Lower Passaic River (River Mile 10.9)
		Project No. 60270961
Photo No. 1	Date: 07072016

Direction Photo Taken: Northwest		
Description: Looking from station 16A-0601 upriver (toward other stations) around low tide.

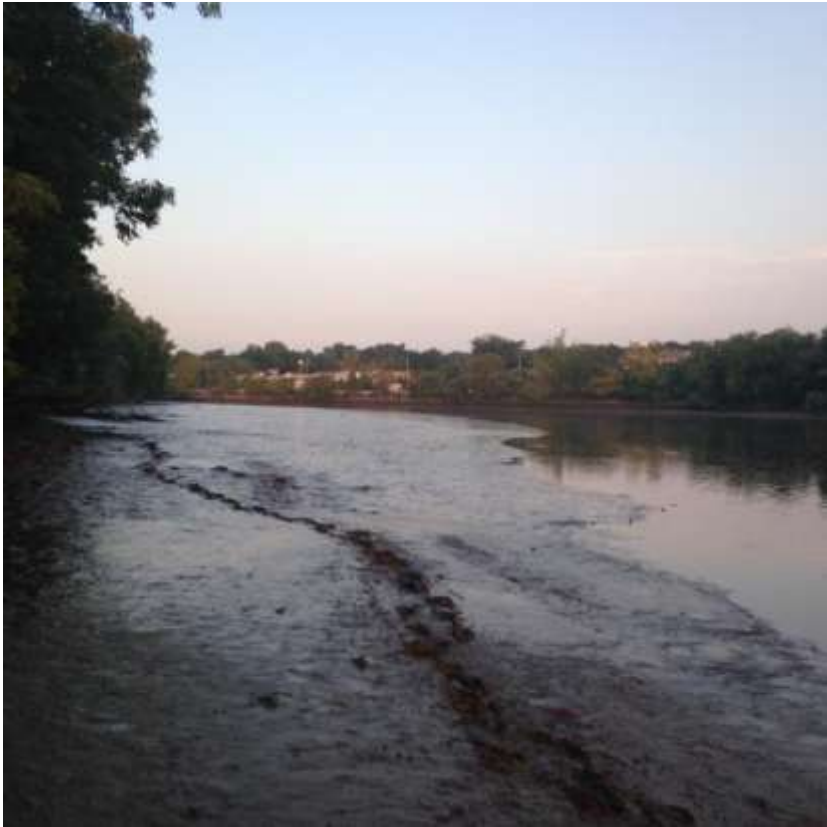
Photo No. 2	Date: 07072016

Direction Photo Taken: South		
Description: Looking downriver from above station 16A-0608 around low tide.

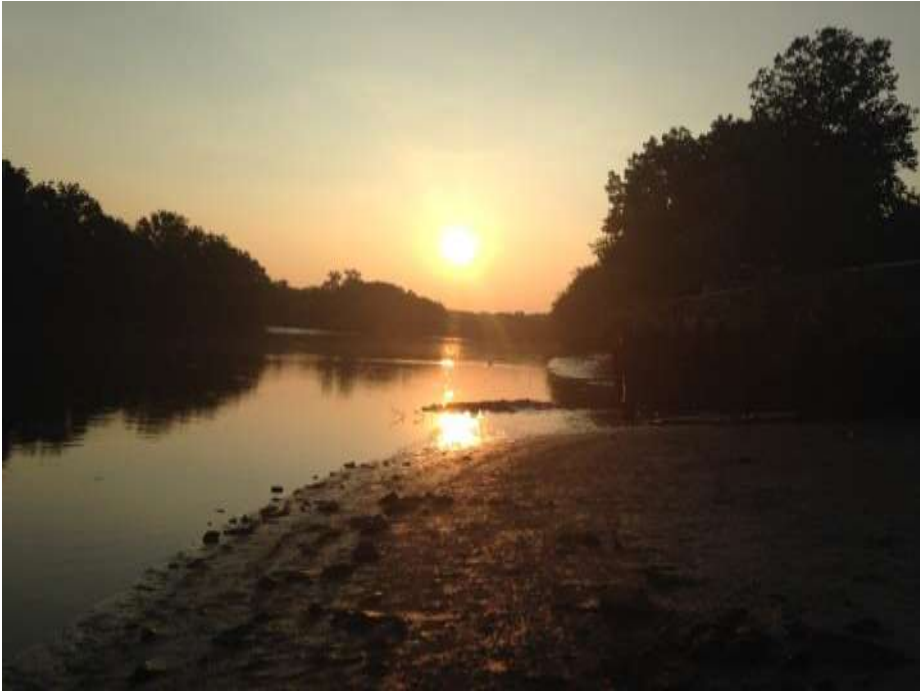
PHOTOGRAPHIC LOG		
Client Name: DMI		Site Location: Lower Passaic River (River Mile 10.9)
Project No. 60270961		
Photo No. 3	Date: 07072016

Direction Photo Taken: Northeast		
Description: Looking upriver from station 16A-0608 around low tide.

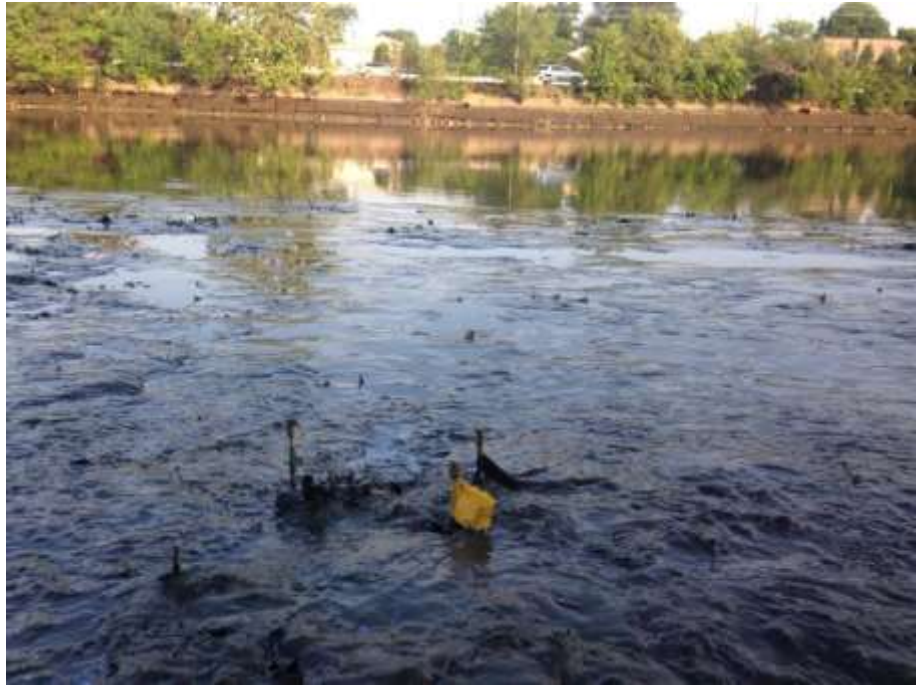
Photo No. 4	Date: 07072016

Direction Photo Taken: West		
Description: Station 16A-0601

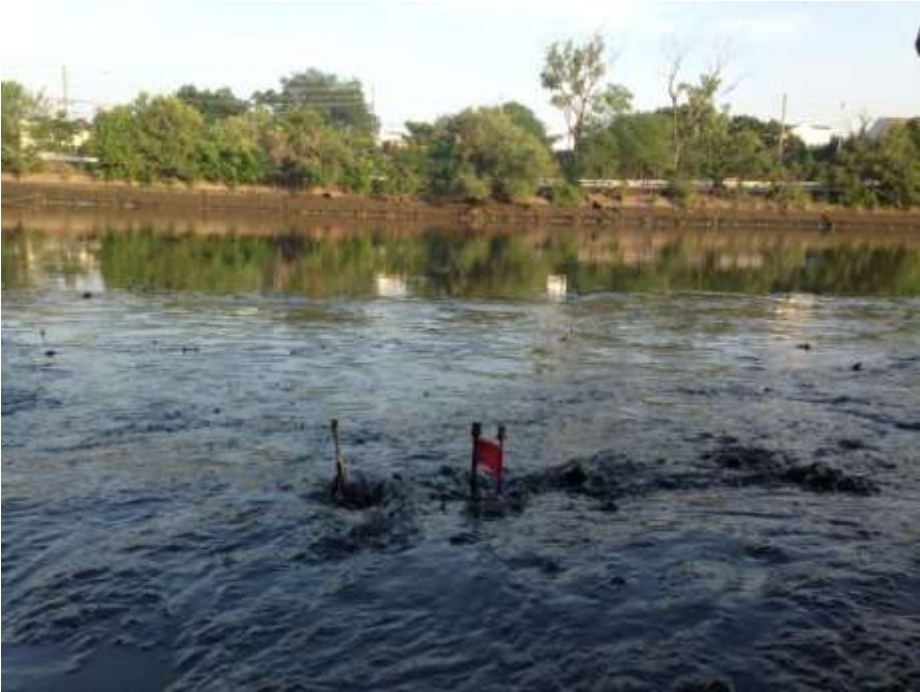
PHOTOGRAPHIC LOG		
Client Name: DMI		Site Location: Lower Passaic River (River Mile 10.9)
Project No. 60270961		
Photo No. 5	Date: 07072016

Direction Photo Taken: Northwest		
Description: Station 16A-0602

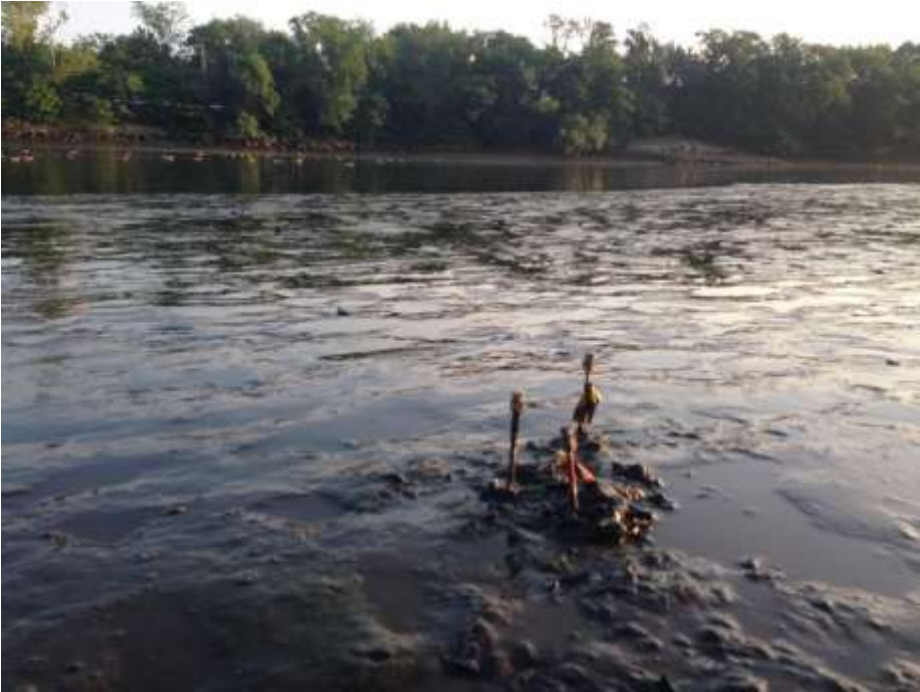
PHOTOGRAPHIC LOG		
Client Name: DMI		Site Location: Lower Passaic River (River Mile 10.9)
Project No. 60270961		
Photo No. 7	Date: 07072016

Direction Photo Taken: North		
Description: Station 16A-0604

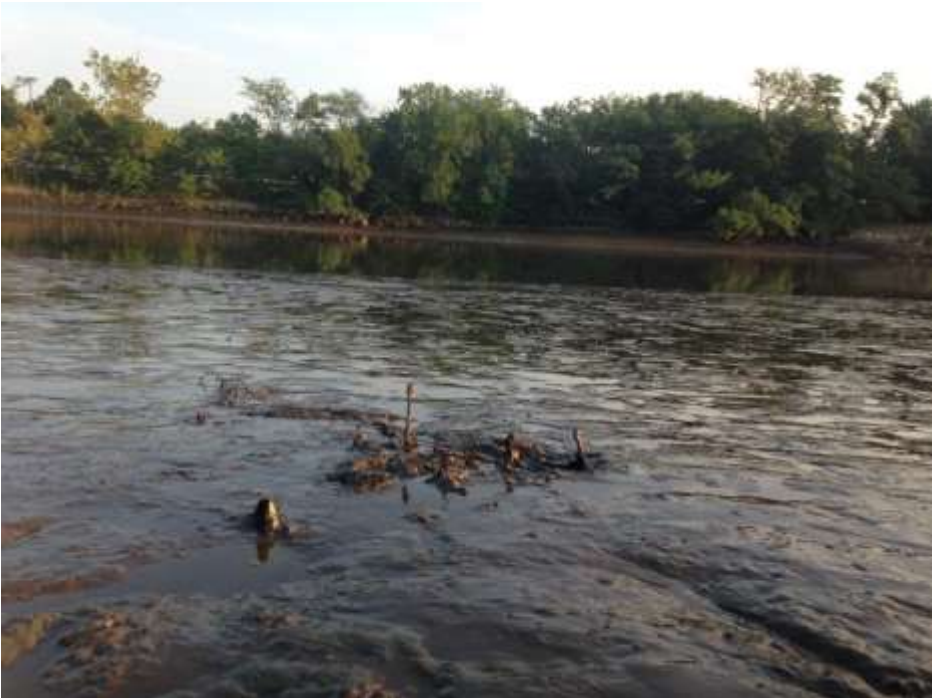
Photo No. 8	Date: 07072016

Direction Photo Taken: Northwest		
Description: Station 16A-0605

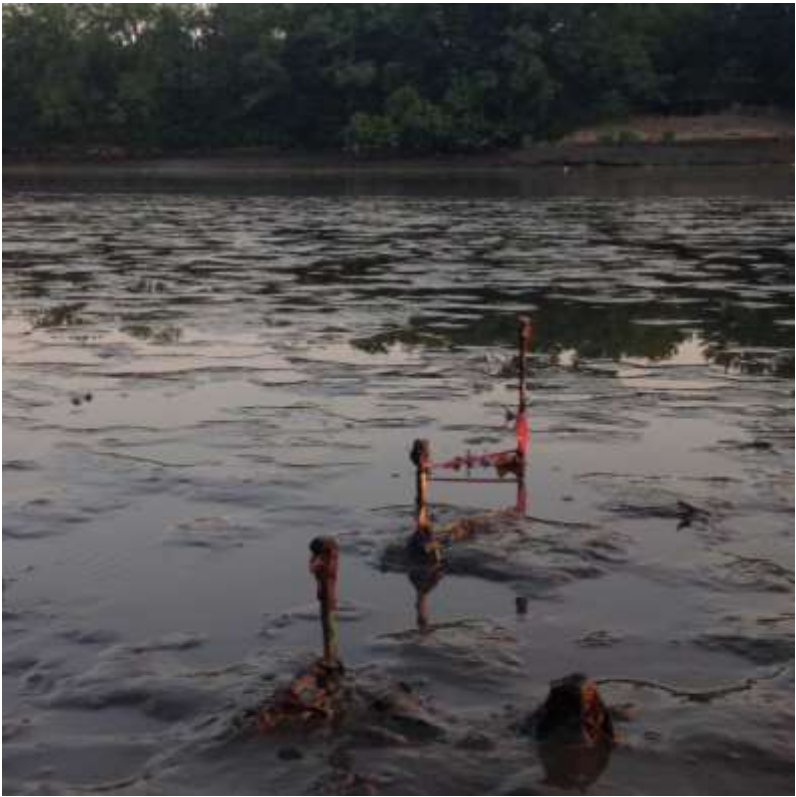
PHOTOGRAPHIC LOG			
Client Name: DMI		Site Location: Lower Passaic River (River Mile 10.9)	Project No. 60270961
Photo No. 9	Date: 07072016

Direction Photo Taken: North			
Description: Station 16A-0606

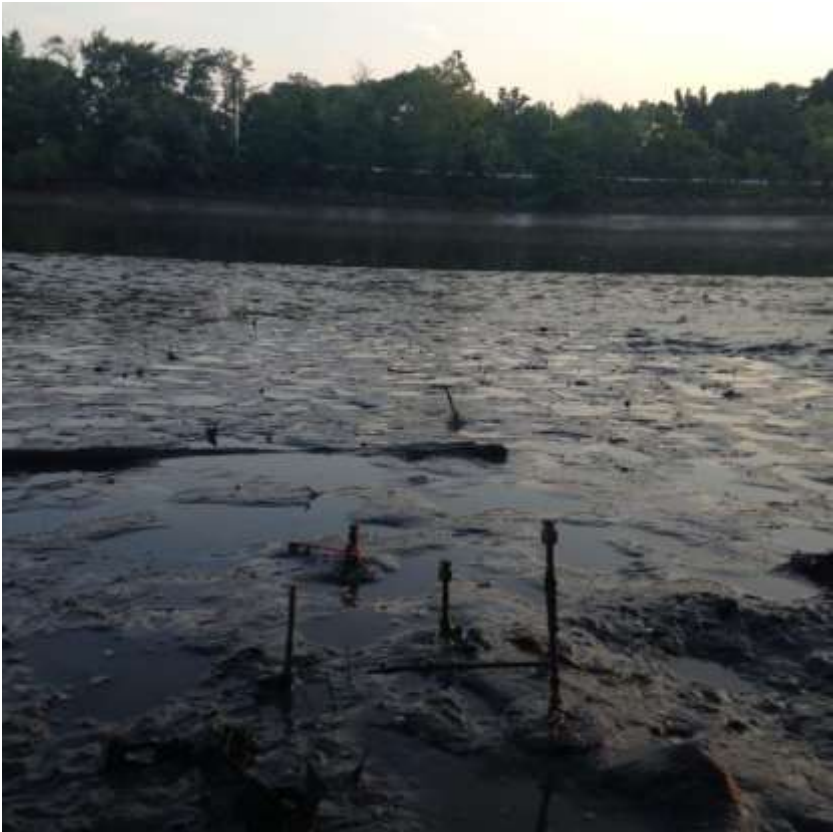
Photo No. 10	Date: 07072016

Direction Photo Taken: North		
Description: Station 16A-0607

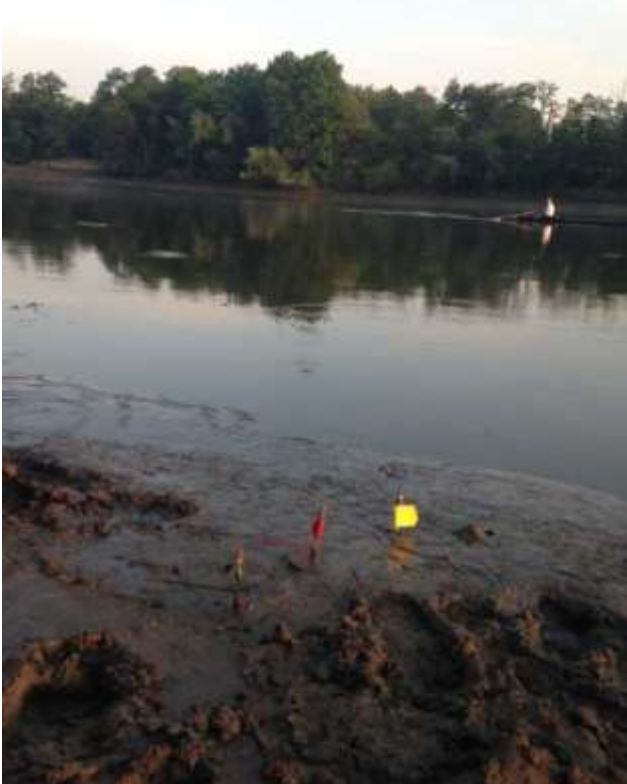
PHOTOGRAPHIC LOG		
Client Name: DMI		Site Location: Lower Passaic River (River Mile 10.9)
Project No. 60270961		
Photo No. 11	Date: 07072016

Direction Photo Taken: North		
Description: Station 16A-0608

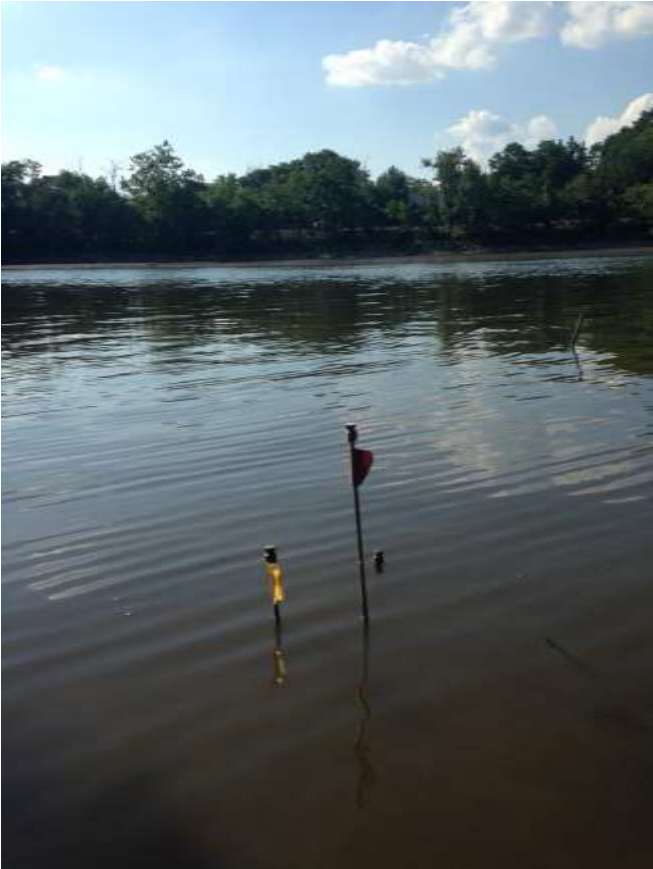
Photo No. 12	Date: 07062016

Direction Photo Taken: North		
Description: Station 16A-0609 (Samplers installed in water in June. Picture taken 35 min before low tide.)

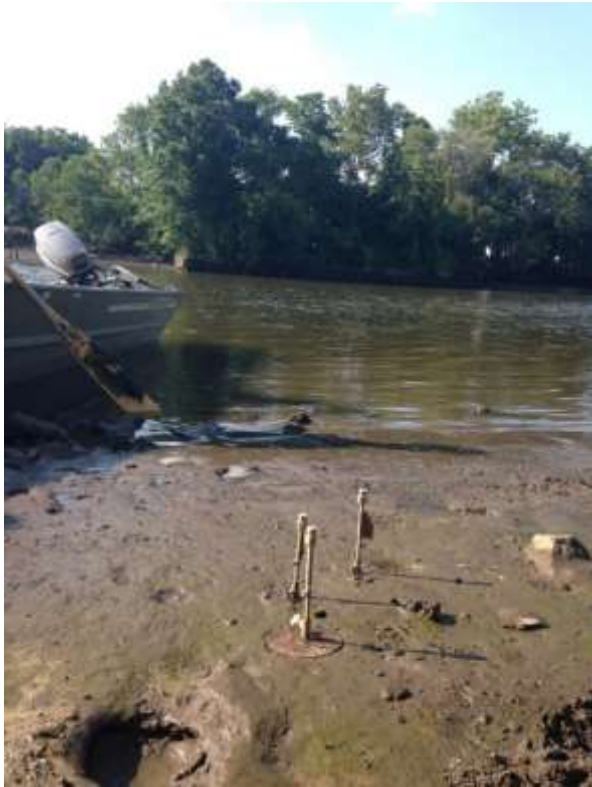
PHOTOGRAPHIC LOG		
Client Name: DMI		Site Location: Lower Passaic River (River Mile 10.9)
Project No. 60270961		
Photo No. 13	Date: 07062016

Direction Photo Taken: North		
Description: Station16A-0610

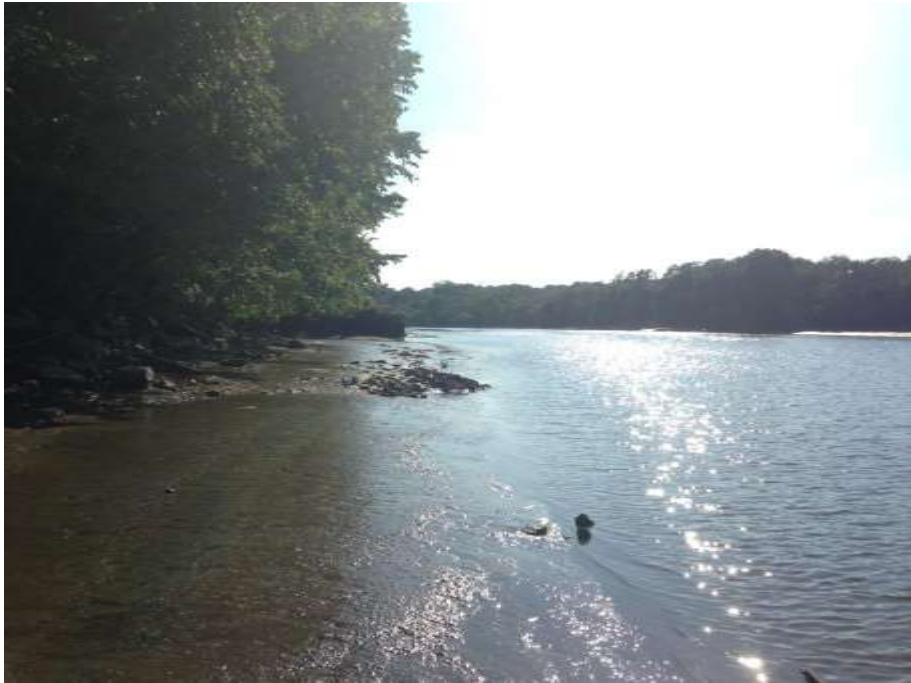
Photo No. 14	Date: 07062016

Direction Photo Taken: West		
Description: Looking downriver toward station 16A-0609 from station 16A-0610.

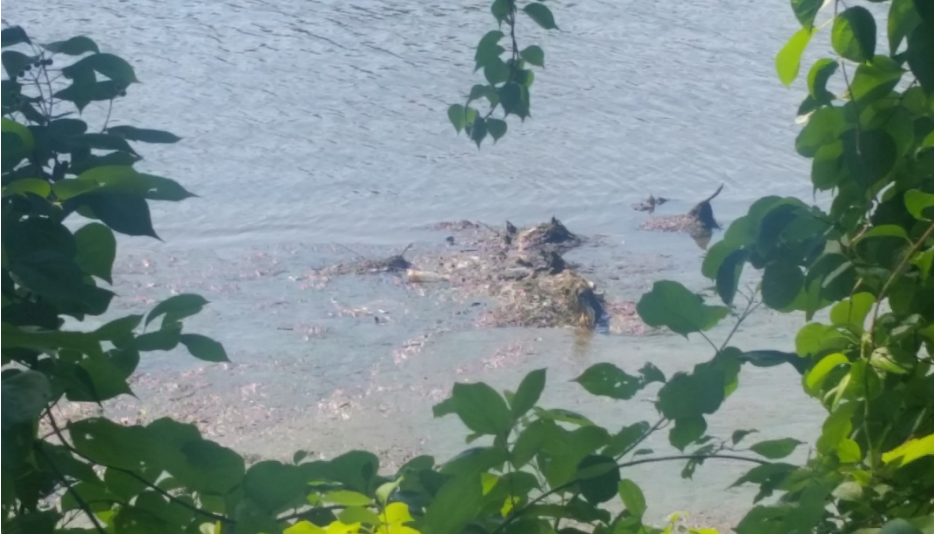
PHOTOGRAPHIC LOG		
Client Name: DMI		Site Location: Lower Passaic River (River Mile 10.9)
		Project No. 60270961
Photo No. 1	Date: 08032016	
Direction Photo Taken: West

Description: 16A-0601 at Low tide.

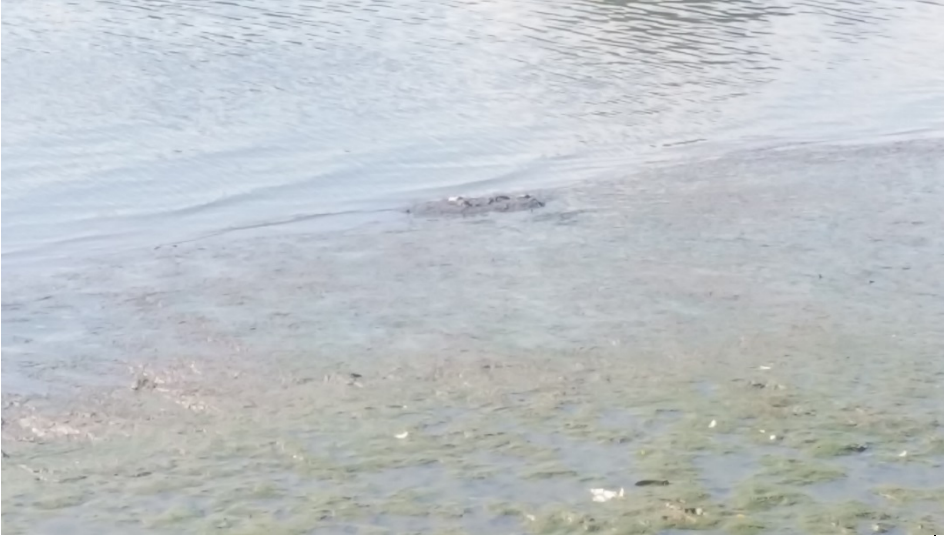
Photo No. 2	Date: 08032016	
Direction Photo Taken: West

Description: 16A-0602 at low tide.

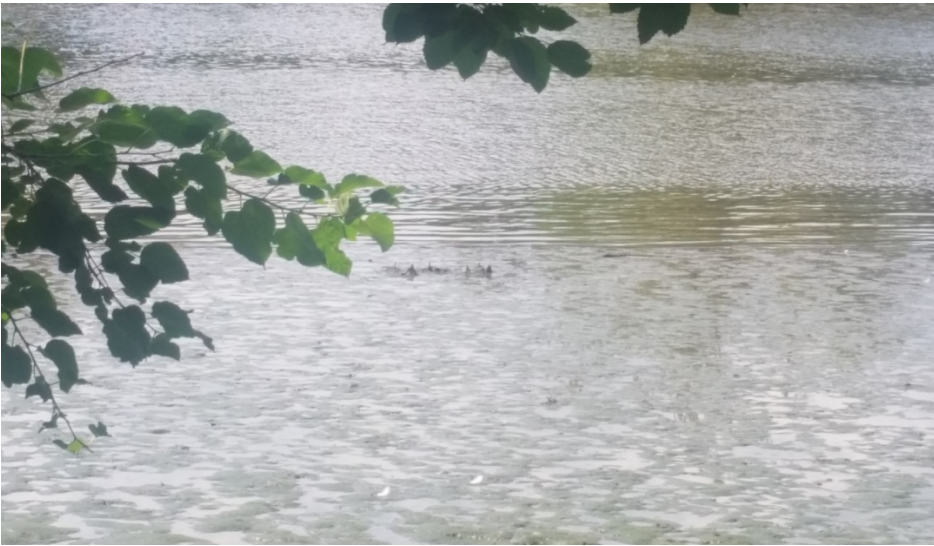
PHOTOGRAPHIC LOG			
Client Name: DMI		Site Location: Lower Passaic River (River Mile 10.9)	Project No. 60270961
Photo No. 3	Date: 08032016

Direction Photo Taken: Northwest			
Description: 16A-0603 and duplicate at low tide			
Photo No. 4	Date: 08032016

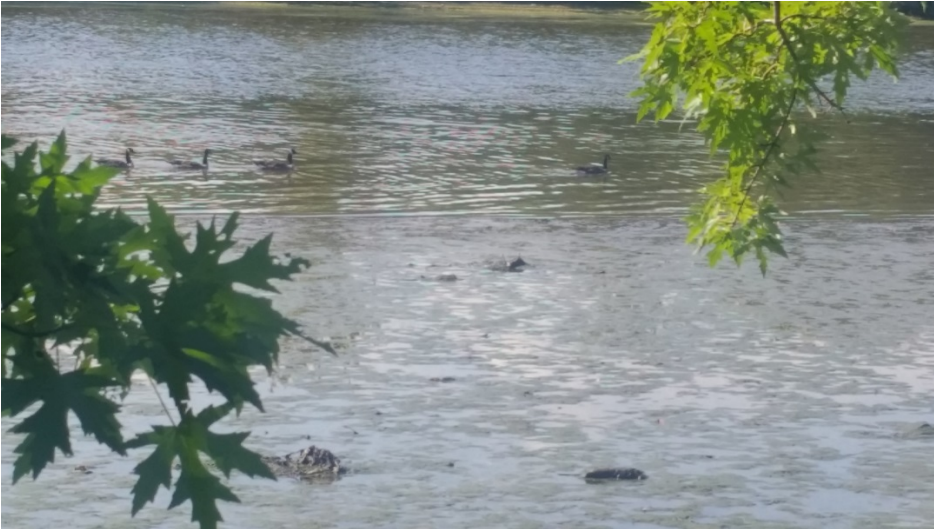
Direction Photo Taken: Northwest			
Description: 16A-0604 at low tide

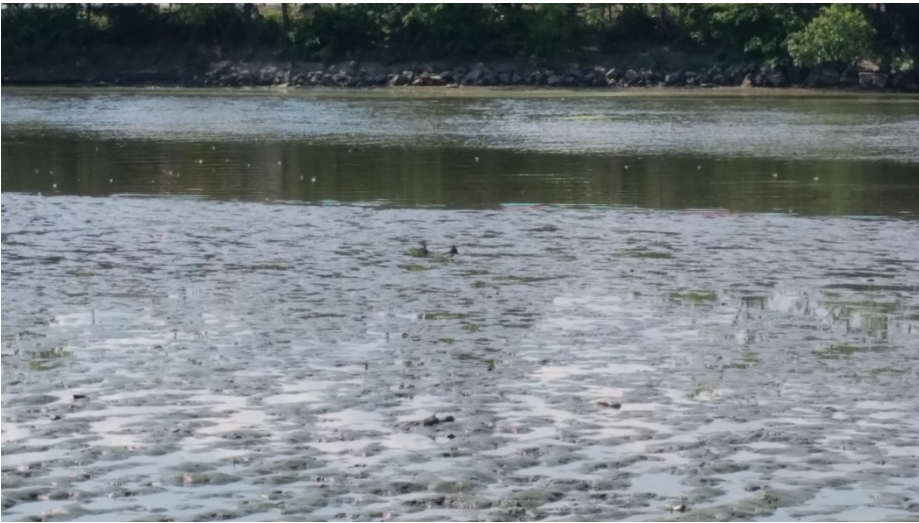
PHOTOGRAPHIC LOG		
Client Name: DMI		Site Location: Lower Passaic River (River Mile 10.9)
Project No. 60270961		
Photo No. 5	Date: 08032016

Direction Photo Taken: Northwest		
Description: 16A-0605 at low tide

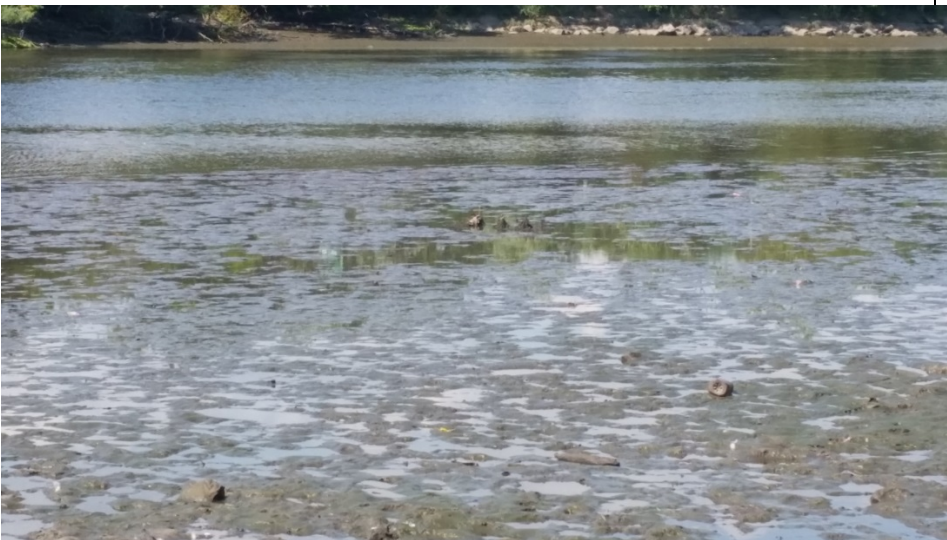
Photo No. 6	Date: 08032016

Direction Photo Taken: Northwest		
Description: 16A-0606 at low tide

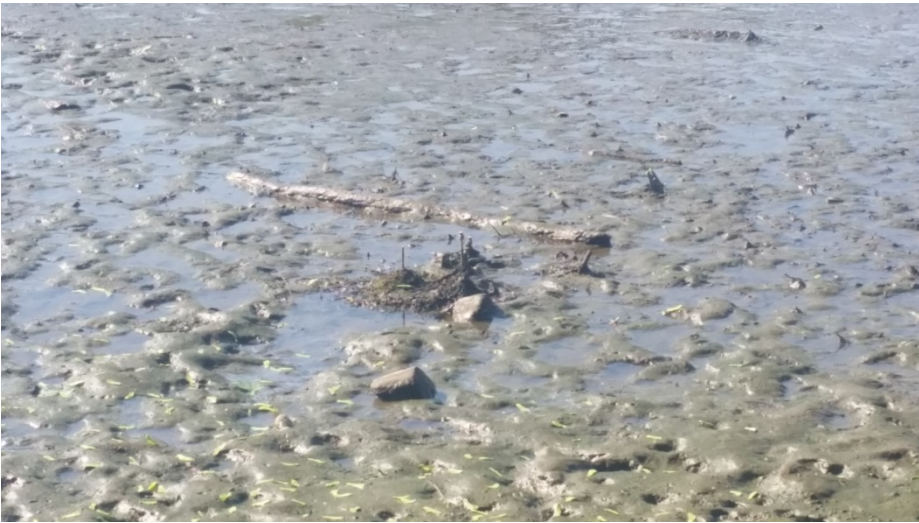
PHOTOGRAPHIC LOG		
Client Name: DMI		Site Location: Lower Passaic River (River Mile 10.9)
Project No. 60270961		
Photo No. 7	Date: 08032016

Direction Photo Taken: North		
Description: 16A-0607 at low tide

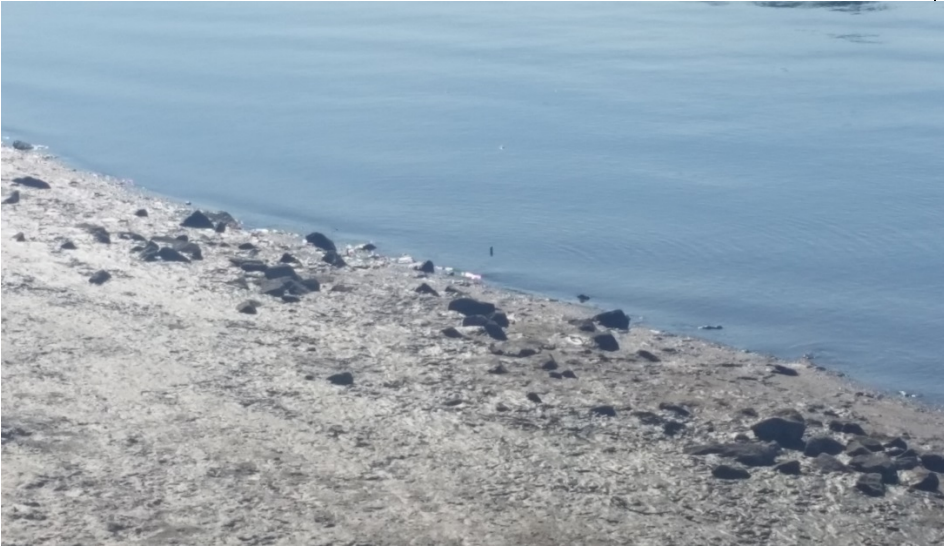
Photo No. 8	Date: 08032016

Direction Photo Taken: North		
Description: 16A-0608 at low tide

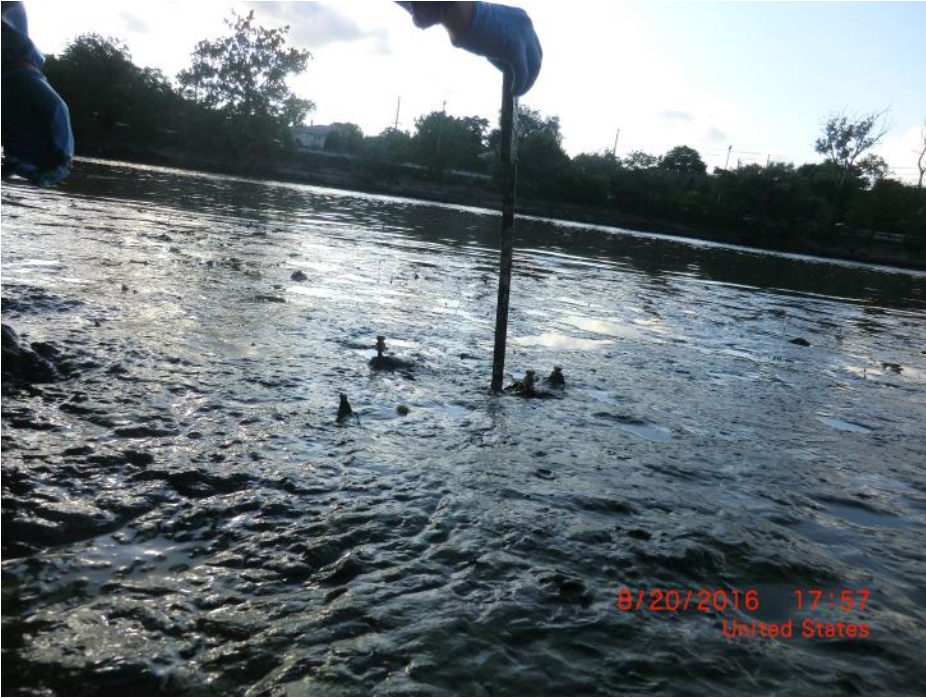
PHOTOGRAPHIC LOG		
Client Name: Cooperating Parties Group		Site Location: Lower Passaic River (River Mile 10.9)
Project No. 60270961		
Photo No. 1	Date: 08202016

Direction Photo Taken: West		
Description: Station 16A-0601

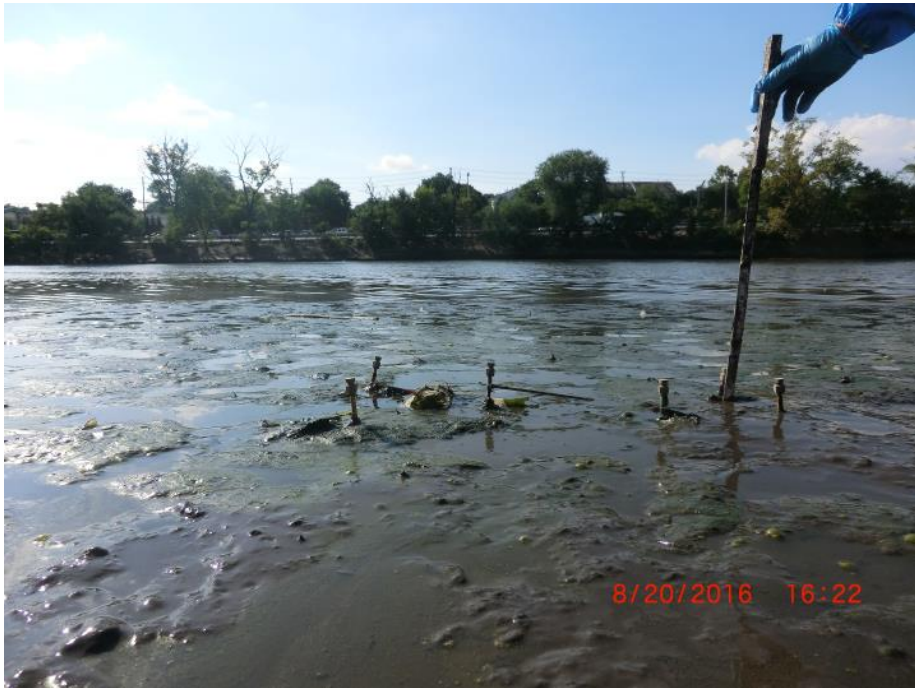
PHOTOGRAPHIC LOG		
Client Name: Cooperating Parties Group		Site Location: Lower Passaic River (River Mile 10.9)
Project No. 60270961		
Photo No. 3	Date: 08202016

Direction Photo Taken: Northwest		
Description: Station 16A-0603 (Right) & Station 16A-0603D (Left)

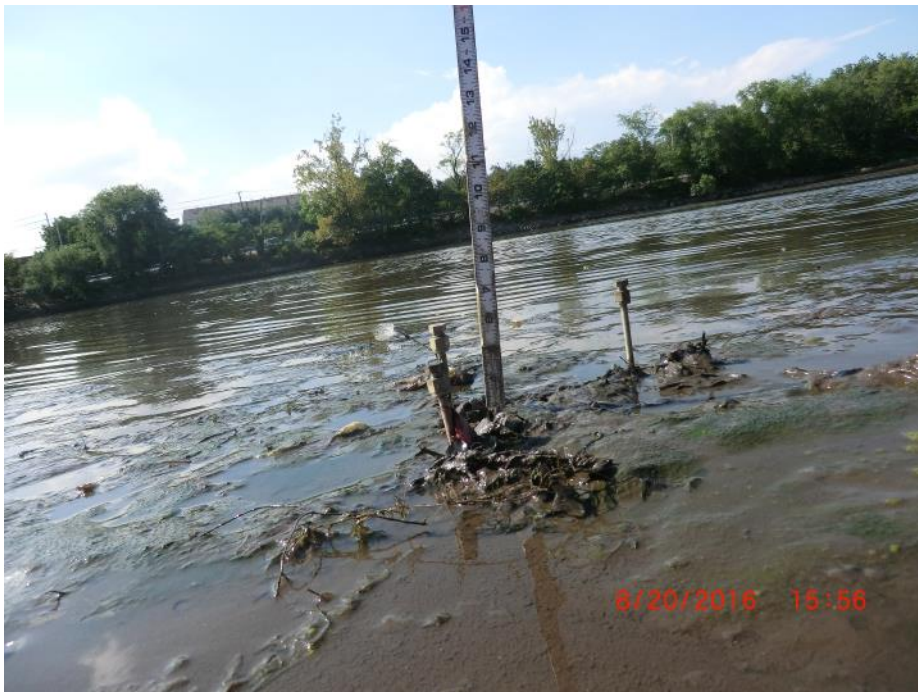
Photo No. 4	Date: 08202016

Direction Photo Taken: North		
Description: Station 16A-0604
